**Flood Control Project Maintenance
Levee Inspections**

Fall 2013 Levee Maintenance Deficiency Summary Report

Reclamation District No. 0765 Glide

Waterway	Bank	Unit Miles
Unit No. 01 Sacramento River	Right	1.74

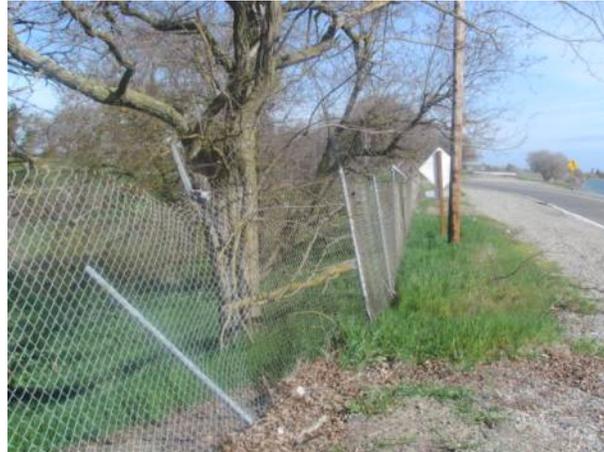
Levee Mile Report Line	7
Start Levee Mile	0.12
End Levee Mile	0.19
Location	Land Side
Category	Earthen Levee
Item	Trim / Thin Trees
Looking west at trees on landside toe.	
richard_f_20130930_755.jpg

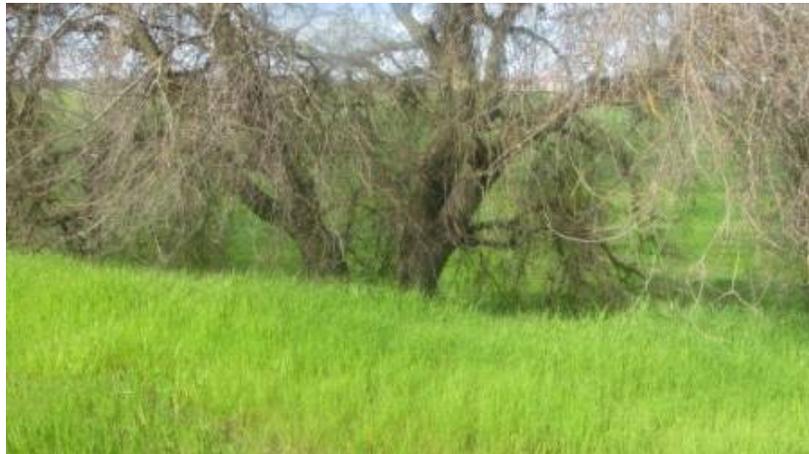
Levee Mile Report Line	7
Start Levee Mile	0.12
End Levee Mile	0.19
Location	Land Side
Category	Earthen Levee
Item	Trim / Thin Trees
Looking downstream (south) at trees on landside slope & toe.	
richard_f_20130930_756.jpg

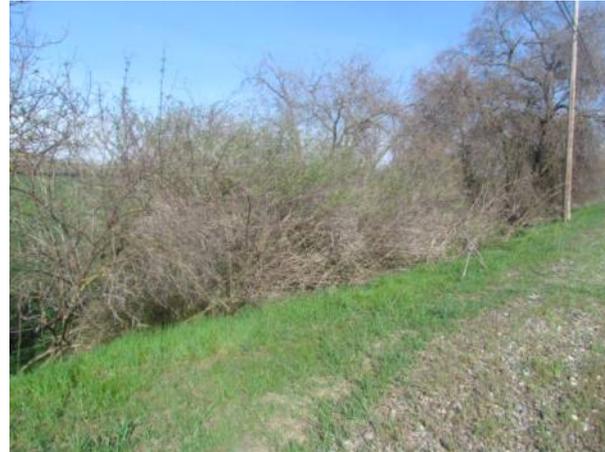
Levee Mile Report Line	12
Start Levee Mile	0.24
End Levee Mile	0.24
Location	Land Side
Category	Earthen Levee
Item	Vegetation
Looking at wild berryvines or wild roses on landside slope and toe.	
richard_f_20130930_775.JPG

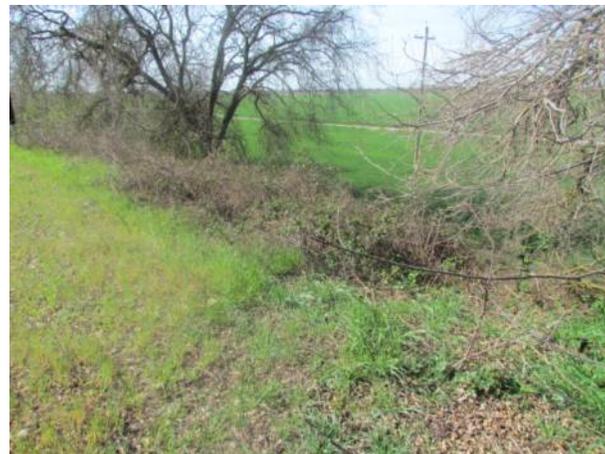
Levee Mile Report Line	13
Start Levee Mile	0.25
End Levee Mile	0.28
Location	Water Side
Category	Earthen Levee
Item	Trim / Thin Trees
Looking northeast at overgrown trees on waterside slope.	
richard_f_20130930_741.jpg

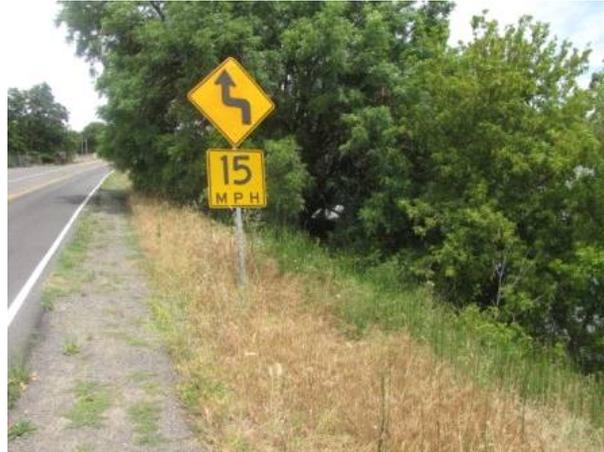
Levee Mile Report Line	13
Start Levee Mile	0.25
End Levee Mile	0.28
Location	Water Side
Category	Earthen Levee
Item	Trim / Thin Trees
Looking upstream (north) at dense vegetation and trees from 2011 spring inspection.	
richard_f_20130930_743.jpg

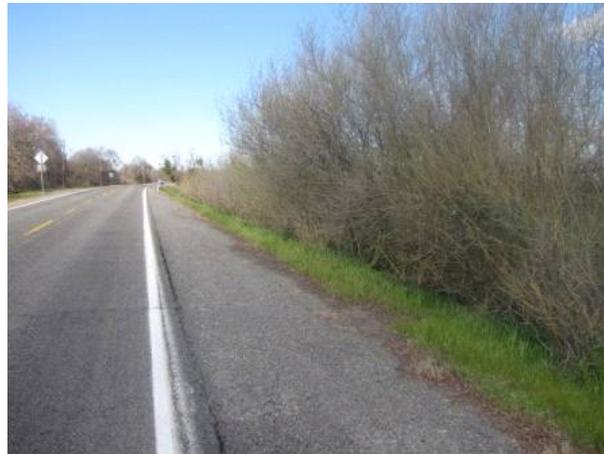
Levee Mile Report Line	13
Start Levee Mile	0.25
End Levee Mile	0.28
Location	Water Side
Category	Earthen Levee
Item	Trim / Thin Trees
Looking north (upstream) at dense trees on landside slope and shoulder. (Spring 2013)	
richard_f_20130930_744.JPG

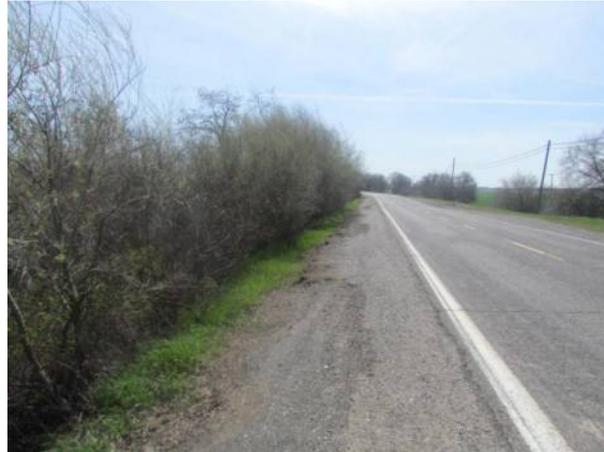
Levee Mile Report Line	14
Start Levee Mile	0.26
End Levee Mile	0.26
Location	Land Side
Category	Earthen Levee
Item	Encroachments
Looking southwest at garbage on landward shoulder and slope.	
richard_f_20131024_108.JPG

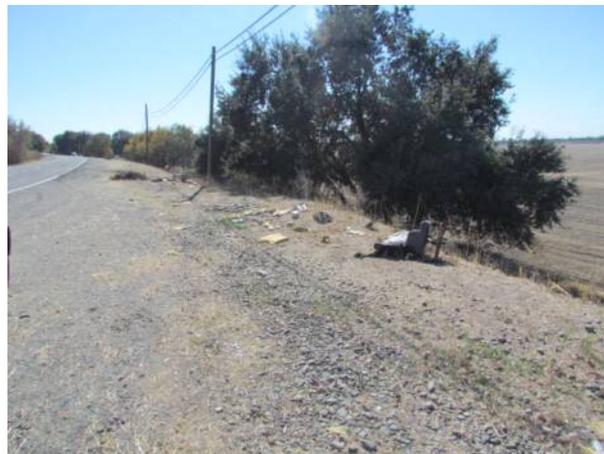
Levee Mile Report Line	16
Start Levee Mile	0.32
End Levee Mile	0.32
Location	Water Side
Category	Earthen Levee
Item	Trim / Thin Trees
Looking north (upstream) at untrimmed trees on waterside shoulder and slope.	
richard_f_20130930_754.JPG

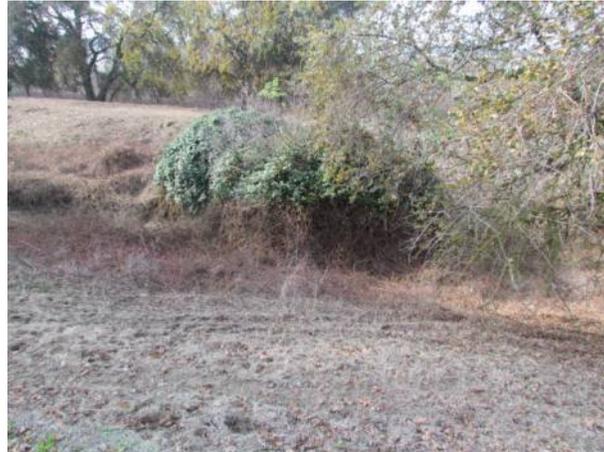
Levee Mile Report Line	20
Start Levee Mile	0.43
End Levee Mile	0.47
Location	Land Side
Category	Earthen Levee
Item	Trim / Thin Trees
Looking southwest at dense vegetation on landside slope and toe.	
richard_f_20130930_762.jpg

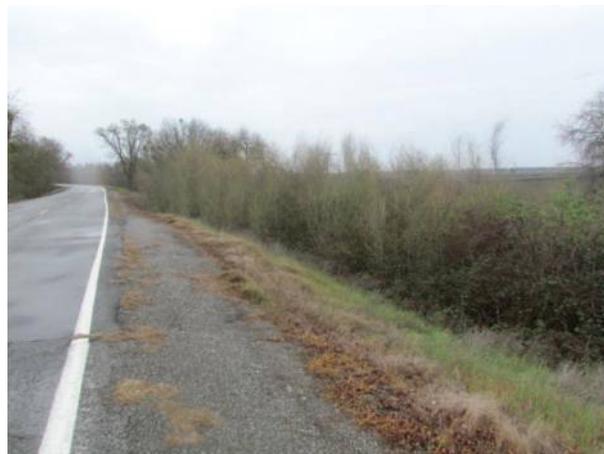
Levee Mile Report Line	21
Start Levee Mile	0.47
End Levee Mile	0.47
Location	Land Side
Category	Earthen Levee
Item	Encroachments
Looking west at garbage on landward slope and toe.	
richard_f_20131024_122.JPG

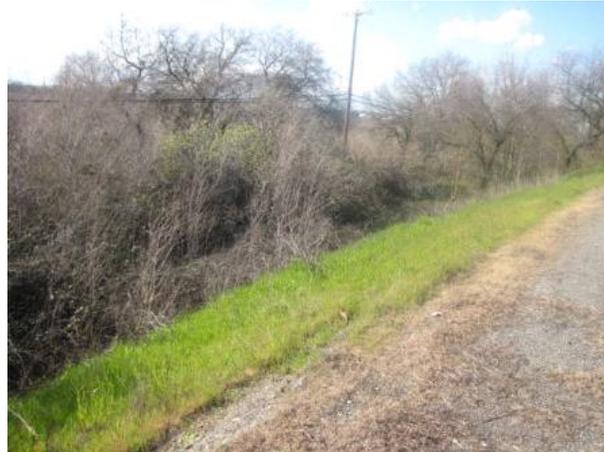
Levee Mile Report Line	22
Start Levee Mile	0.48
End Levee Mile	0.50
Location	Land Side
Category	Earthen Levee
Item	Vegetation
Looking southwest at dense vegetation on landside slope and toe.	
richard_f_20130930_767.JPG

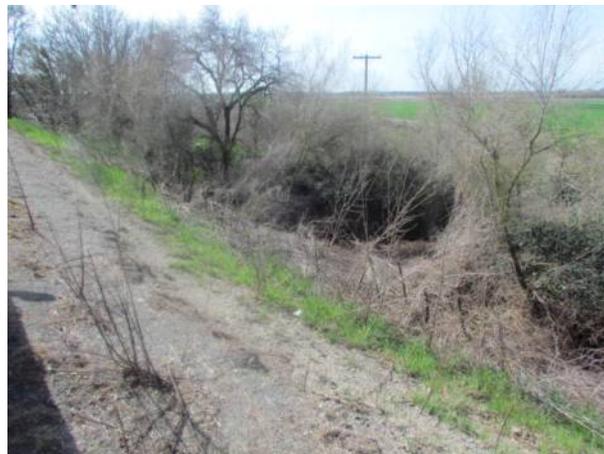
Levee Mile Report Line	28
Start Levee Mile	0.76
End Levee Mile	0.80
Location	Land Side
Category	Earthen Levee
Item	Vegetation
Looking northwest at vegetation on landside slope.	
richard_f_20130930_776.JPG

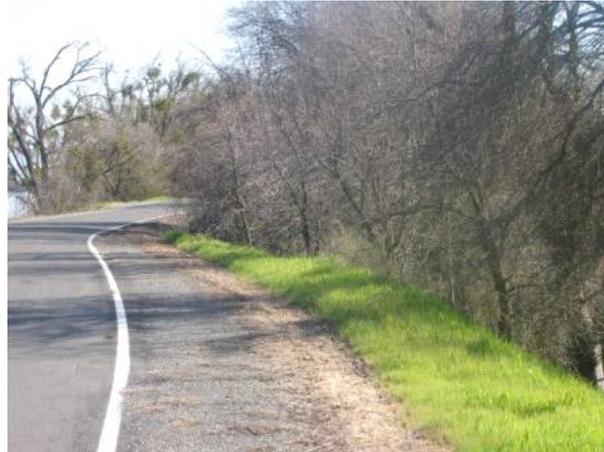
Levee Mile Report Line	30
Start Levee Mile	0.87
End Levee Mile	0.99
Location	Land Side
Category	Earthen Levee
Item	Trim / Thin Trees
Looking upstream (north) at dense trees on landside slope and toe.	
richard_f_20130930_749.jpg

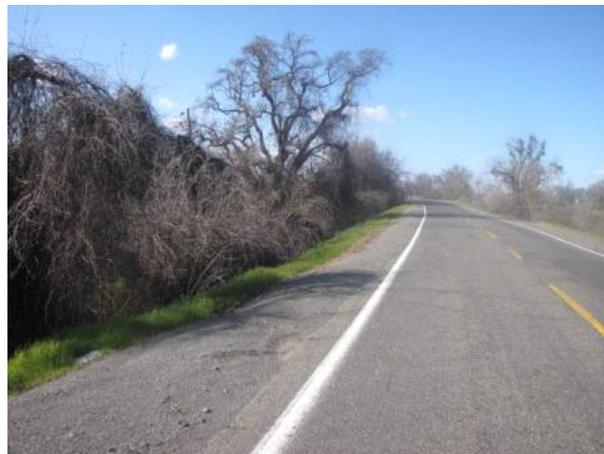
Levee Mile Report Line	30
Start Levee Mile	0.87
End Levee Mile	0.99
Location	Land Side
Category	Earthen Levee
Item	Trim / Thin Trees
Looking south at dense trees on landside shoulder and slope. (November 2011)	
richard_f_20130930_750.jpg

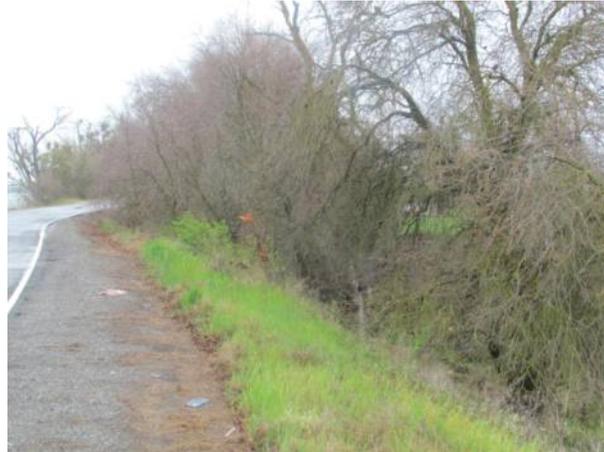
Levee Mile Report Line	30
Start Levee Mile	0.87
End Levee Mile	0.99
Location	Land Side
Category	Earthen Levee
Item	Trim / Thin Trees
Looking southwest at dense vegetation on landward slope.	
richard_f_20131024_115.JPG

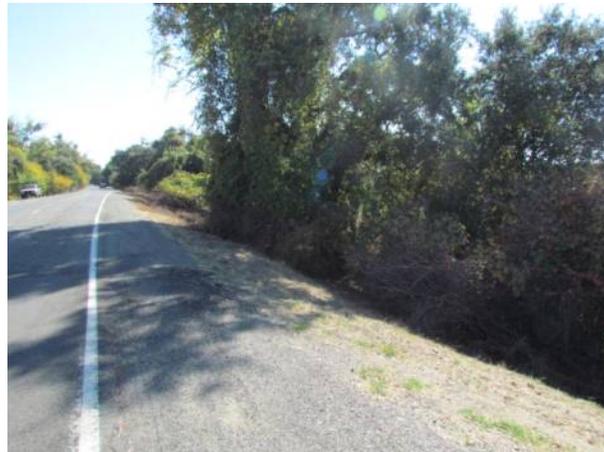
Levee Mile Report Line	31
Start Levee Mile	0.97
End Levee Mile	0.97
Location	Land Side
Category	Earthen Levee
Item	Vegetation
Looking west at dense berryvines and wildroses on landside shoulder and slope. (November 2011)	
richard_f_20130930_779.jpg

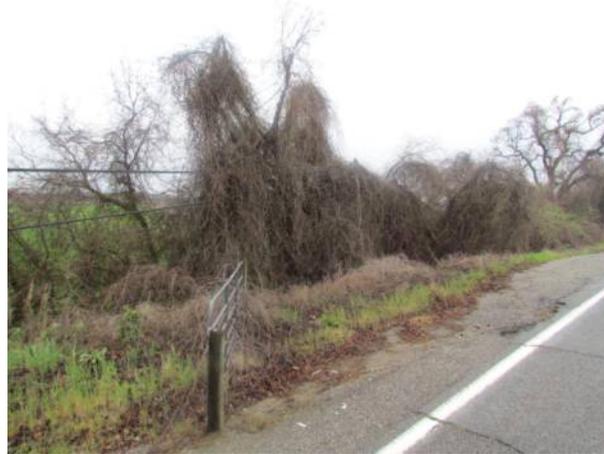
Levee Mile Report Line	31
Start Levee Mile	0.97
End Levee Mile	0.97
Location	Land Side
Category	Earthen Levee
Item	Vegetation
Looking west at trimmed trees on landward slope.	
richard_f_20131024_118.JPG

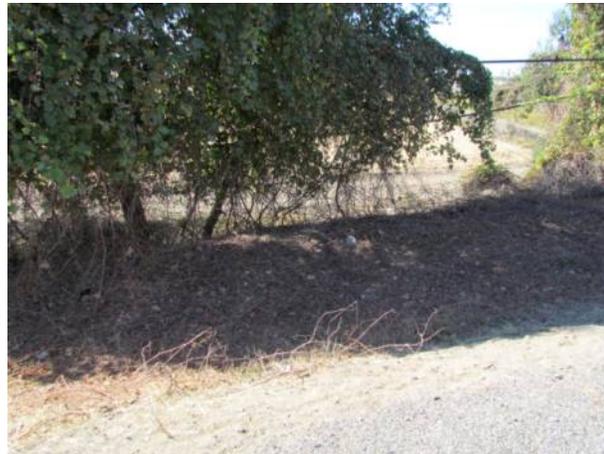
Levee Mile Report Line	32
Start Levee Mile	0.99
End Levee Mile	0.99
Location	Land Side
Category	Earthen Levee
Item	Encroachments
Looking southwest at irrigation ditch on landward toe.	
richard_f_20131024_119.JPG

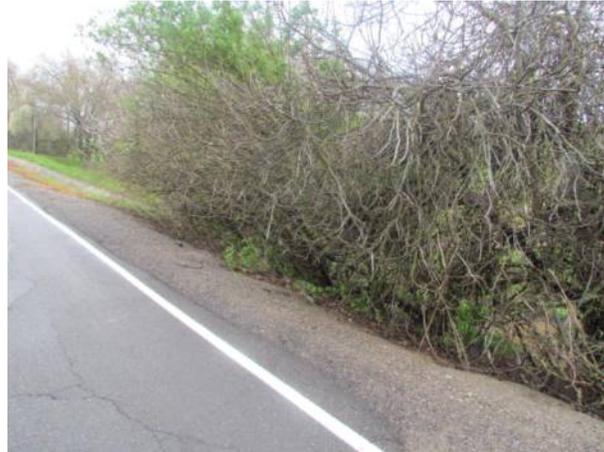
Levee Mile Report Line	35
Start Levee Mile	1.04
End Levee Mile	1.04
Location	Land Side
Category	Earthen Levee
Item	Vegetation
Looking west at cactus at landside toe.	
richard_f_20130930_747.JPG

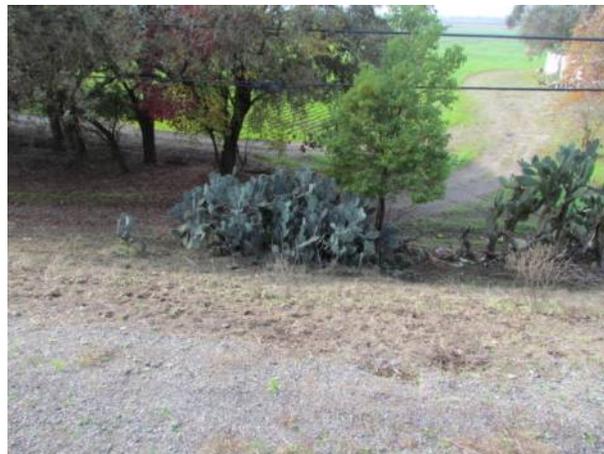
Levee Mile Report Line	36
Start Levee Mile	1.08
End Levee Mile	1.08
Location	Land Side
Category	Earthen Levee
Item	Trim / Thin Trees
Looking downstream (south) at trees on landside slope & toe from 2010 fall inspection.	
richard_f_20130930_768.jpg

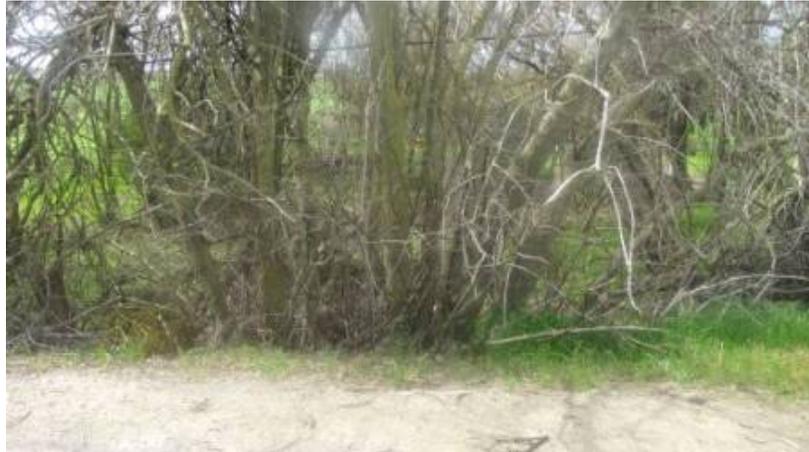
Levee Mile Report Line	36
Start Levee Mile	1.08
End Levee Mile	1.08
Location	Land Side
Category	Earthen Levee
Item	Trim / Thin Trees
Looking downstream (southwest) at dense trees on landside slope and toe.	
richard_f_20130930_770.jpg

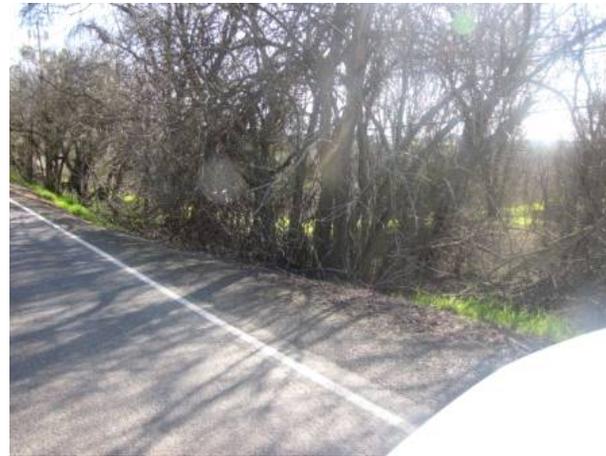
Levee Mile Report Line	36
Start Levee Mile	1.08
End Levee Mile	1.08
Location	Land Side
Category	Earthen Levee
Item	Trim / Thin Trees
Looking southwest at trees on landward slope.	
richard_f_20131024_120.JPG

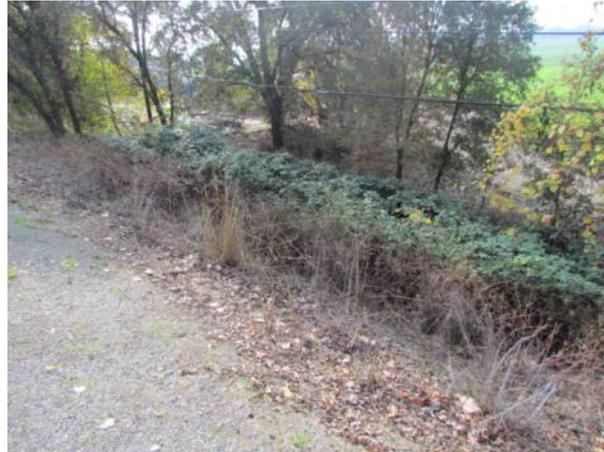
Levee Mile Report Line	40
Start Levee Mile	1.19
End Levee Mile	1.22
Location	Land Side
Category	Earthen Levee
Item	Encroachments
Looking northwest at buildings along landside toe.	
richard_f_20130930_772.jpg

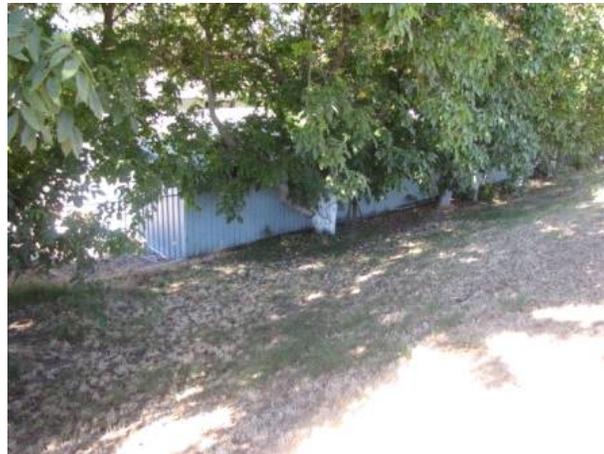
Levee Mile Report Line	41
Start Levee Mile	1.32
End Levee Mile	1.34
Location	Water Side
Category	Earthen Levee
Item	Slope Stability
Looking north at slope damage on waterward shoulder.	
richard_f_20131024_114.JPG

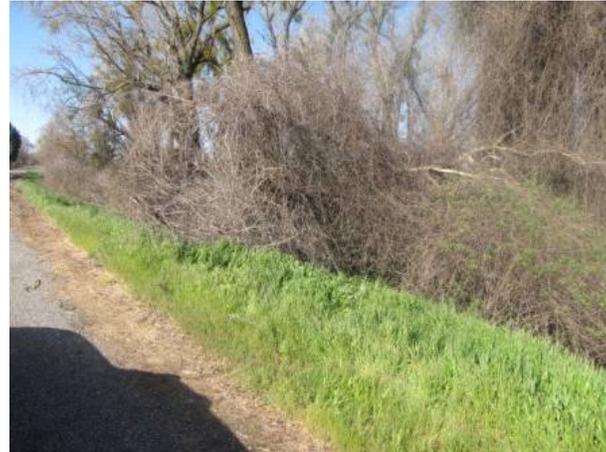
Levee Mile Report Line	44
Start Levee Mile	1.36
End Levee Mile	1.36
Location	Water Side
Category	Earthen Levee
Item	Vegetation
Looking southeast at dense vegetation on waterside slope. (Fall Inspection 2012)	
richard_f_20130930_740.JPG

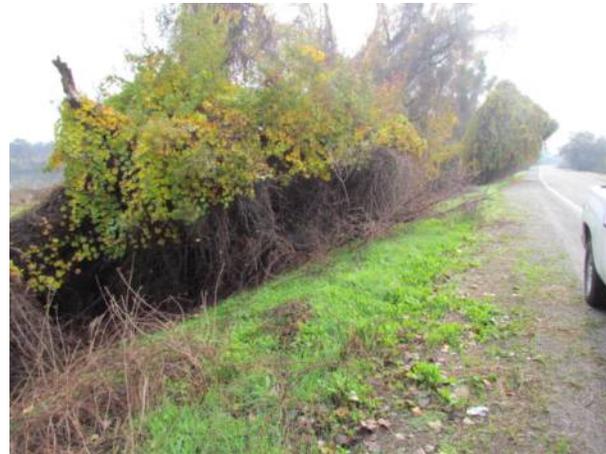
Levee Mile Report Line	47
Start Levee Mile	1.44
End Levee Mile	1.47
Location	Water Side
Category	Earthen Levee
Item	Trim / Thin Trees
Looking upstream (north) at dense trees on waterside slope.	
richard_f_20130930_737.jpg

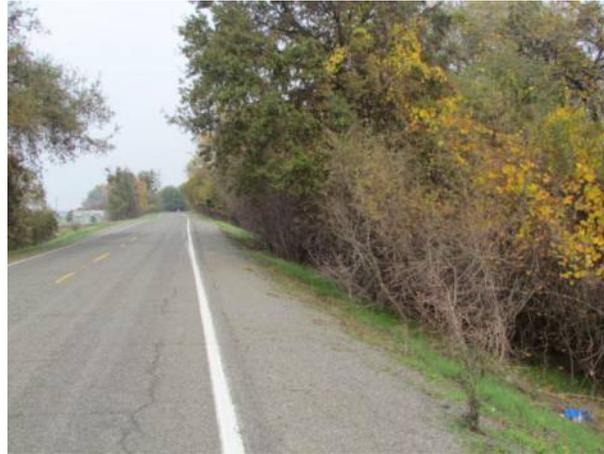
Levee Mile Report Line	49
Start Levee Mile	1.48
End Levee Mile	1.48
Location	Land Side
Category	Earthen Levee
Item	Slope Stability

Looking west at slope damage on landward slope.

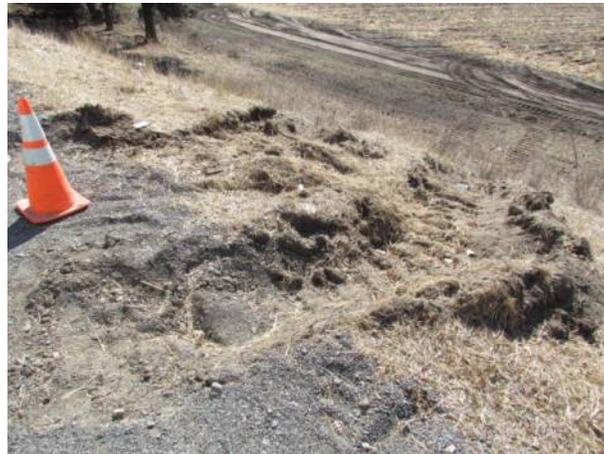
Levee Mile Report Line	50
Start Levee Mile	1.48
End Levee Mile	1.48
Location	Water Side
Category	Earthen Levee
Item	Slope Stability

Looking southeast at slope damage on waterward slope.

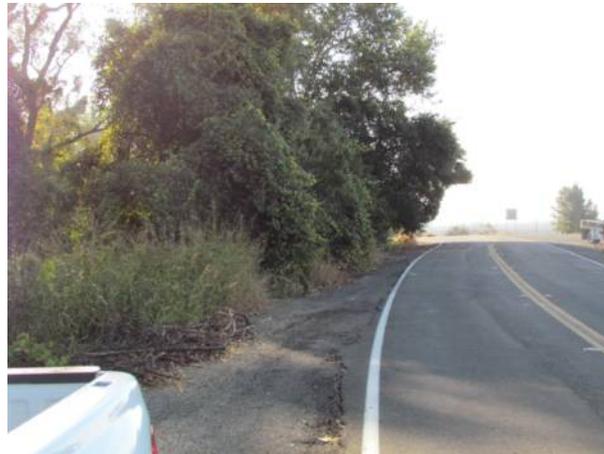
Levee Mile Report Line	52
Start Levee Mile	1.52
End Levee Mile	1.73
Location	Water Side
Category	Earthen Levee
Item	Vegetation
Looking north at dense vegetation on waterside slope.	
richard_f_20130930_733.JPG

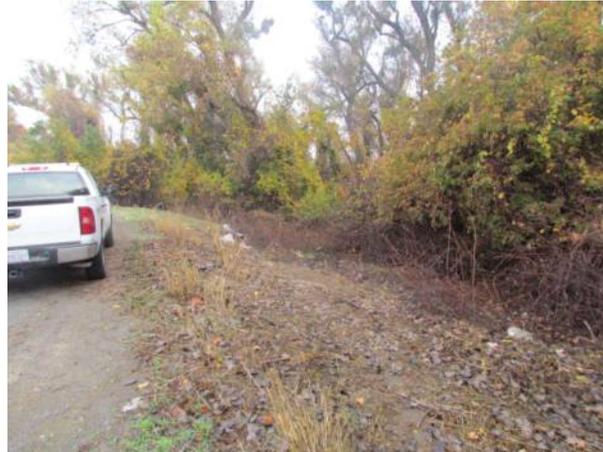
Levee Mile Report Line	53
Start Levee Mile	1.54
End Levee Mile	1.54
Location	Land Side
Category	Earthen Levee
Item	Trim / Thin Trees
Looking south at dense vegetation on landside shoulder and slope. (November 2011)	
richard_f_20130930_757.jpg

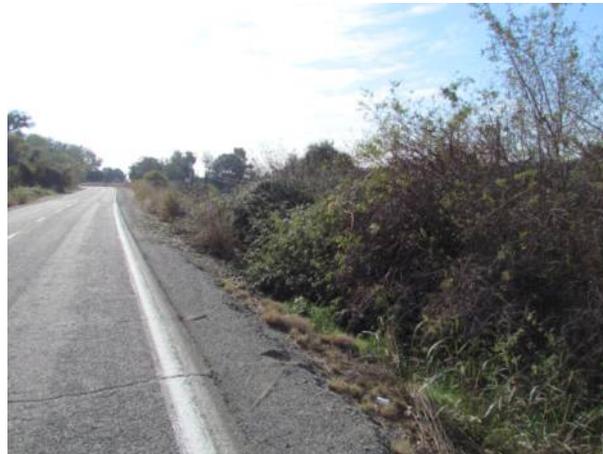
Levee Mile Report Line	53
Start Levee Mile	1.54
End Levee Mile	1.54
Location	Land Side
Category	Earthen Levee
Item	Trim / Thin Trees
Looking south at dense vegetation on landside slope and toe spring 2012.	
richard_f_20130930_758.jpg
